INSPECTION REPORT

For the Property at:
1234 BRONCO
CORONA, CA

Prepared for: DOE JOHN
Inspection Date: Tuesday, July 4, 2006
Prepared by: Jim Ruether

RE: Report No. 1002, v.5
1234 Bronco
Corona, CA

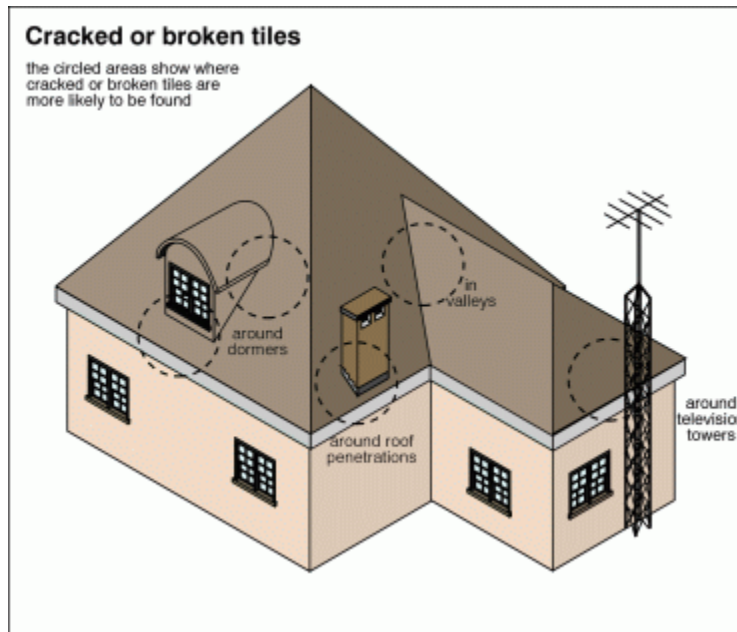
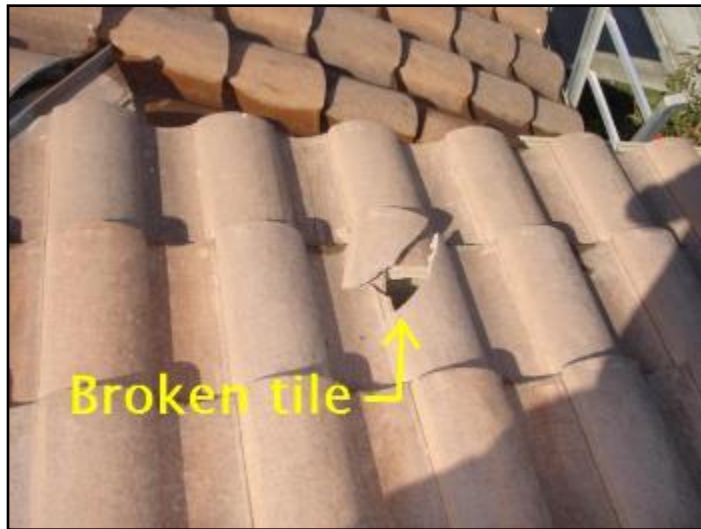
Condition: • [Missing, loose or broken pieces](#)

Implication(s): Chance of water damage to contents, finishes and/or structure | Damage or physical injury due to falling materials

Location: Various

- I recommend having the roof evaluated and or repaired by a licensed roofing contractor.

Task: Replace

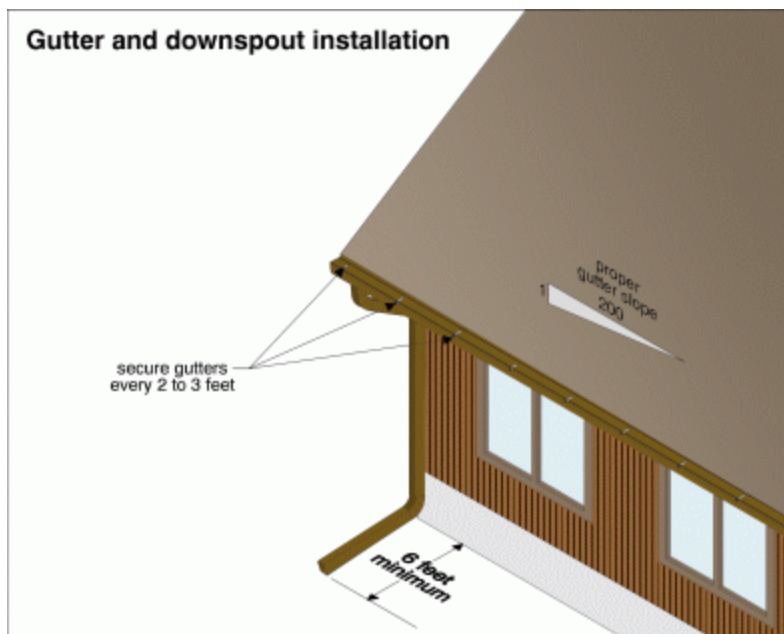
Condition: • [Downspouts end too close to building](#)

Implication(s): Chance of water damage to contents, finishes and/or structure

Location: North Exterior Porch

Task: Provide

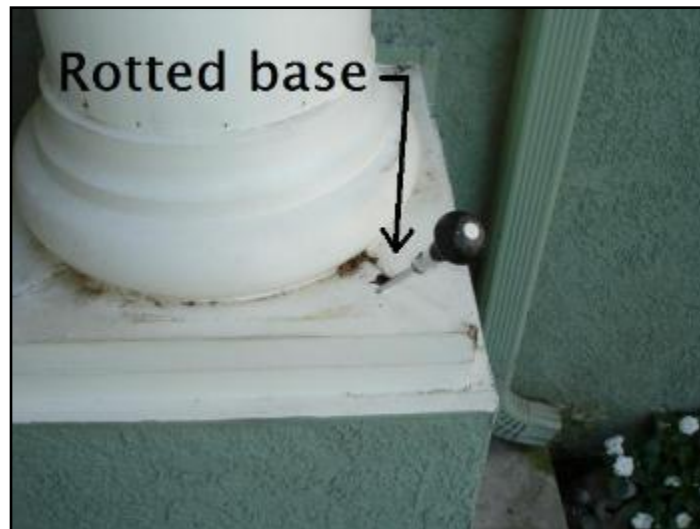
Condition: • [Rot or insect damage](#)

Implication(s): Weakened structure | Chance of movement

Location: North Second floor Porch

Task: Repair or replace

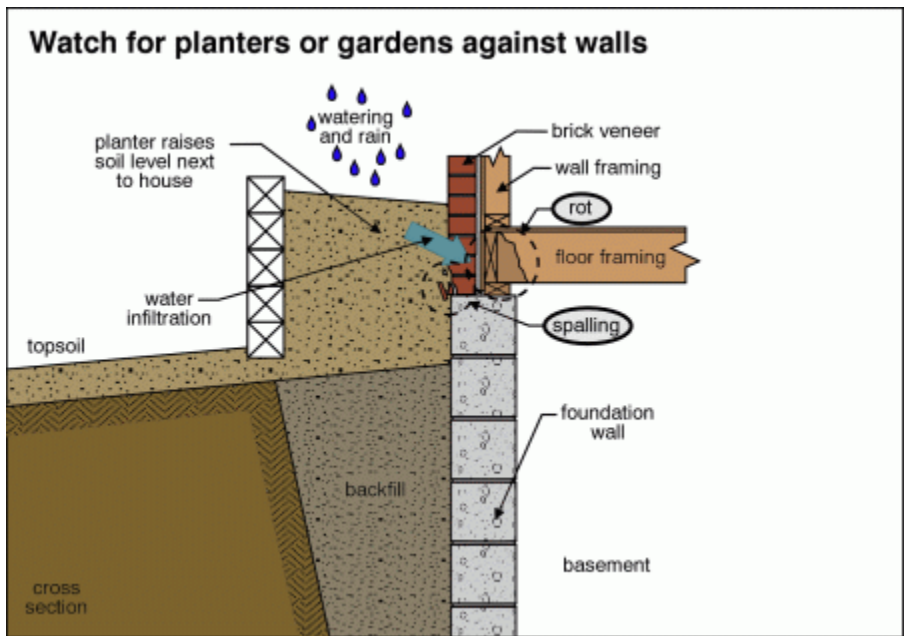
Condition: • [Loose](#)

Implication(s): Fall hazard

Location: North Second floor Porch

Condition: • [Planters and gardens against walls](#)

Implication(s): Chance of water entering house | Chance of damage to structure | Chance of structural movement

Task: Service

Task: Provide water control

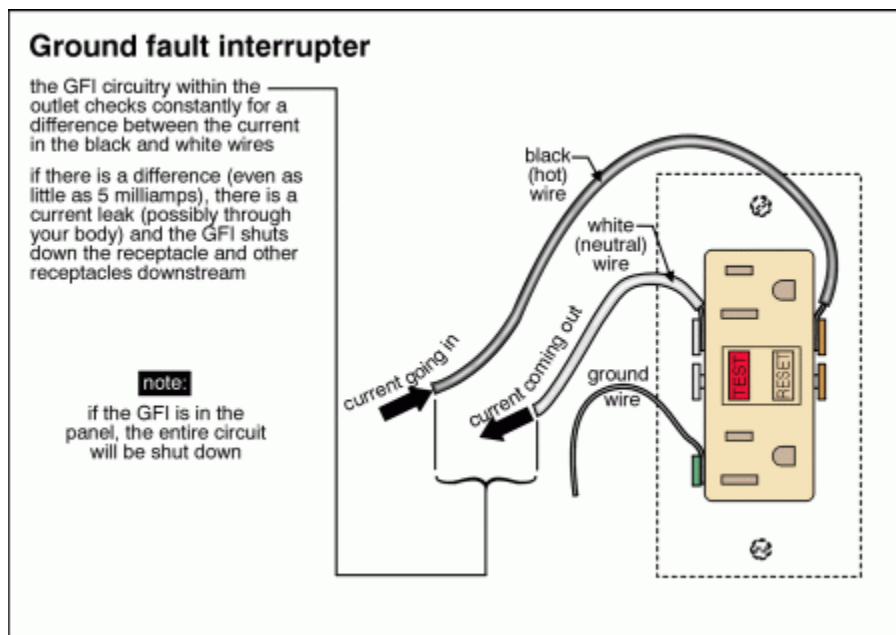
Condition: • [No GFI](#)

Implication(s): Electric shock

Location: Kitchen

Task: Provide

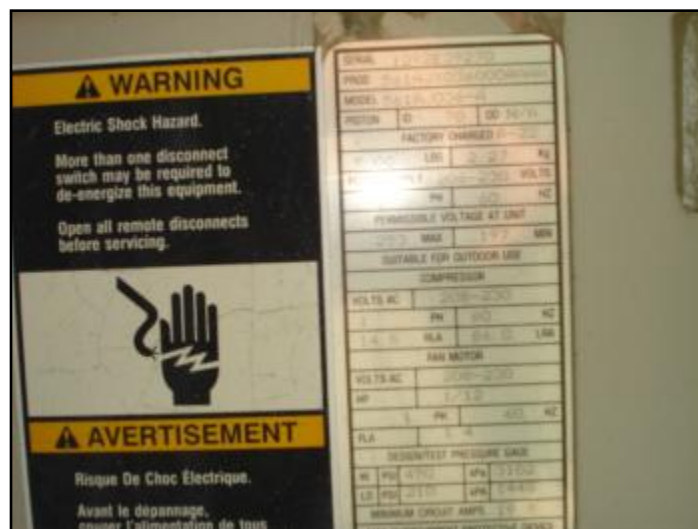
14 RLA Both compressors=> 12.5-12.9 good

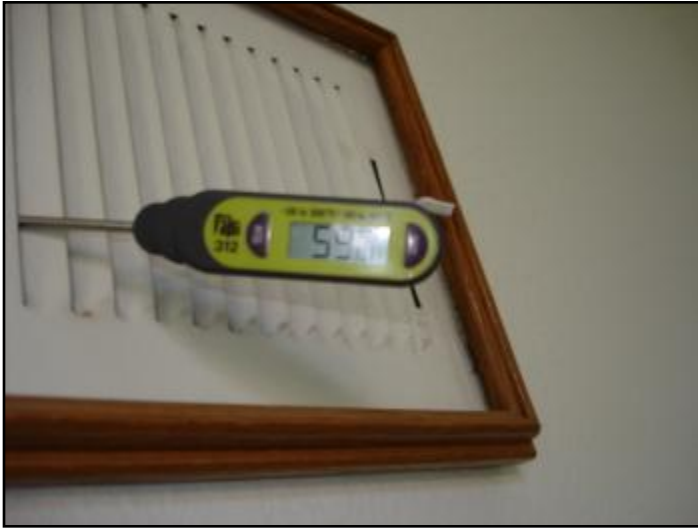
Supply 60 deg aprox

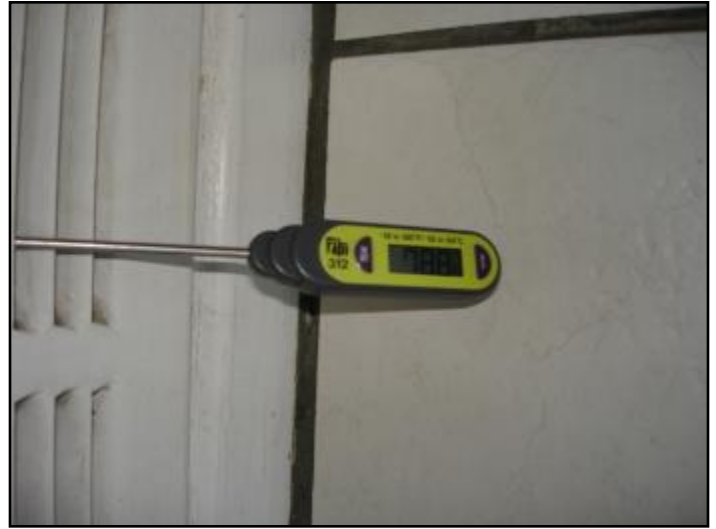
Return 80 deg aprox = 20 deg difference, good

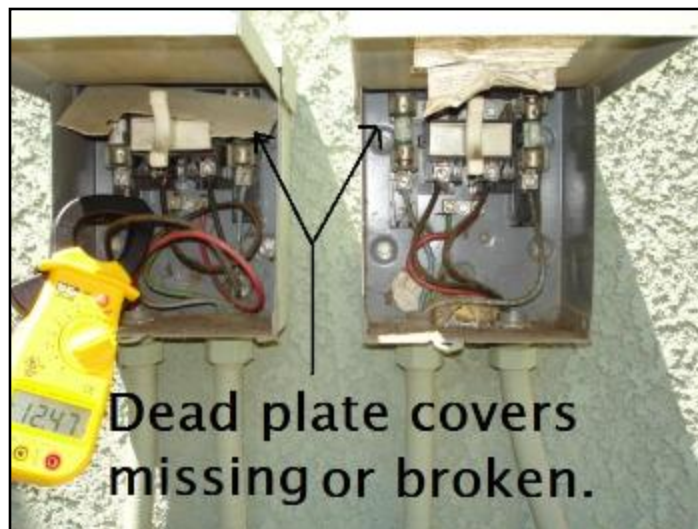
Condition: • Electrical shut off missing dead plates.

Location: East Exterior wall

Task: Repair

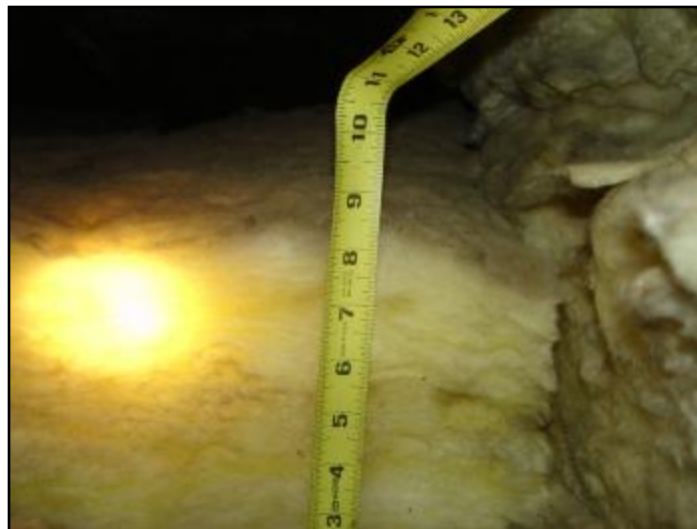
Condition: • [Amount less than current standards](#)

Implication(s): Increased heating and cooling costs

8" of fiberglass = aprox 24 R Value -32 min

Task: Provide

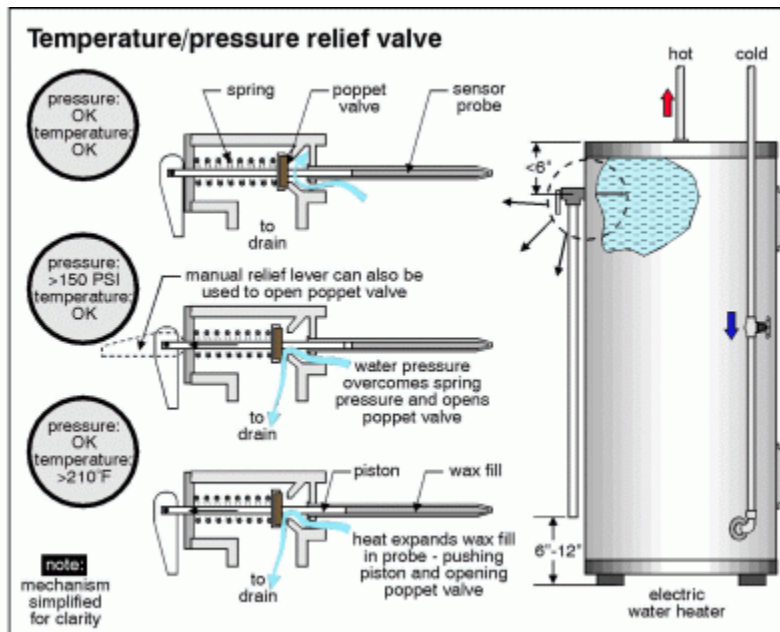
Condition: • [Missing](#)

Implication(s): Steam explosion

Location: Garage

Task: Provide

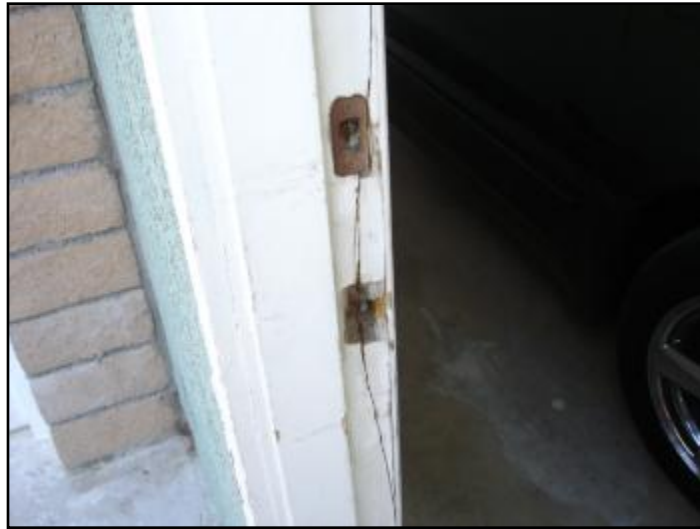
Condition: • Strike plate missing on garage

man door.

Needs strike plates & repair

Task: Replace jamb

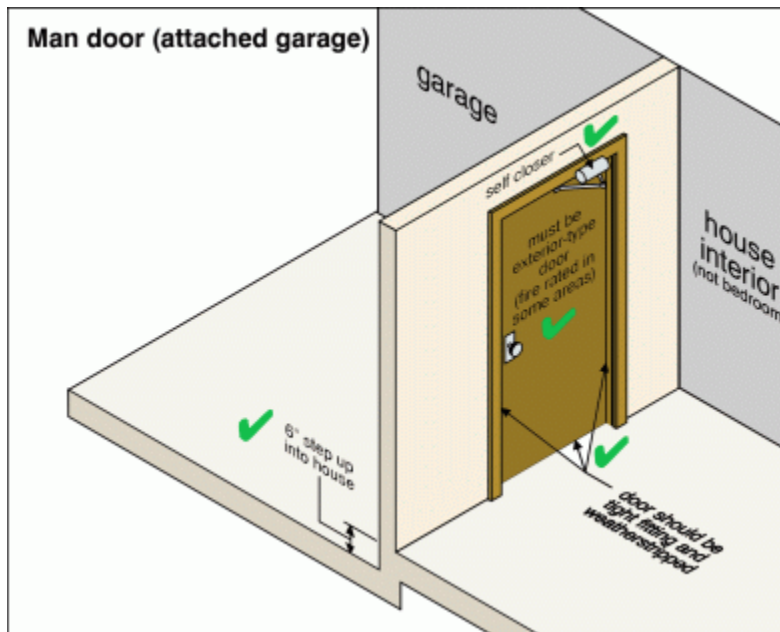
Condition: • [No self closer](#)

Implication(s): Hazardous combustion products entering home

Task: Correct

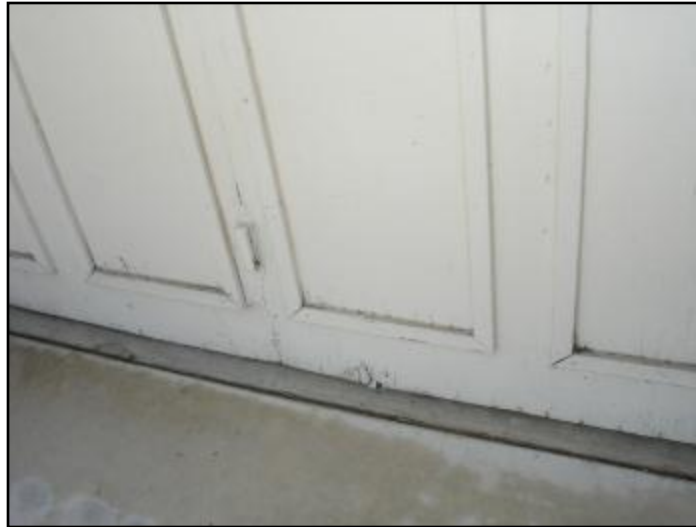
Condition: • Needs paint

Location: Garage doors

Task: Paint and seal.
